# Prop Scarring... More than a Trace Left Behind

Bill Goodwin, Nancy Diersing, FKNMS

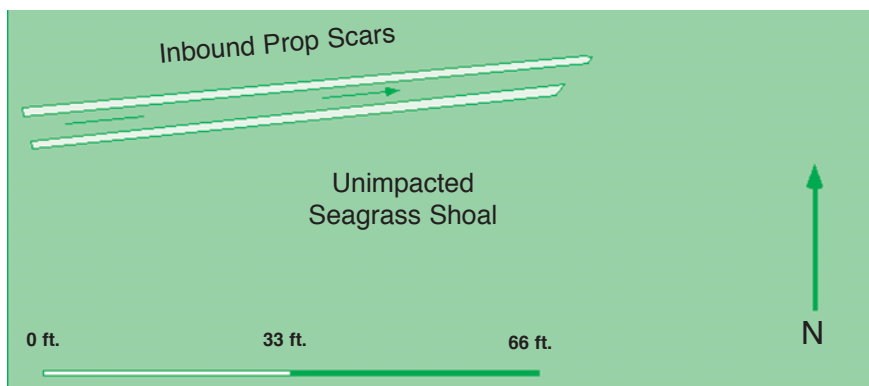
The diagrams on this page were created to document the sequence of events that occurred when a twin-engine boat grounded on a seagrass flat within the Sanctuary. First, the boat propellers dredged parallel prop scars across the seagrass flat (above left). The severity of a scar left by a propeller is apparent in the underwater photograph (above right).

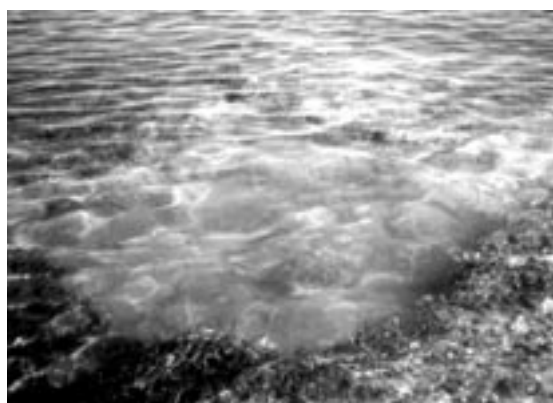
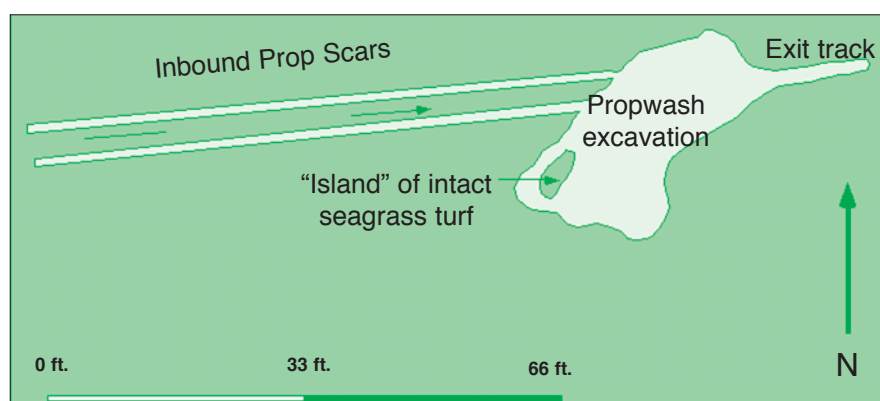
Second, when the boat operator attempted to "power off" using the engines, a barren sandy crater known as a "blow-hole" was created (above left). An exit track was also dredged leaving behind an intact "island" of seagrass turf and a propwash blow-hole (above right).

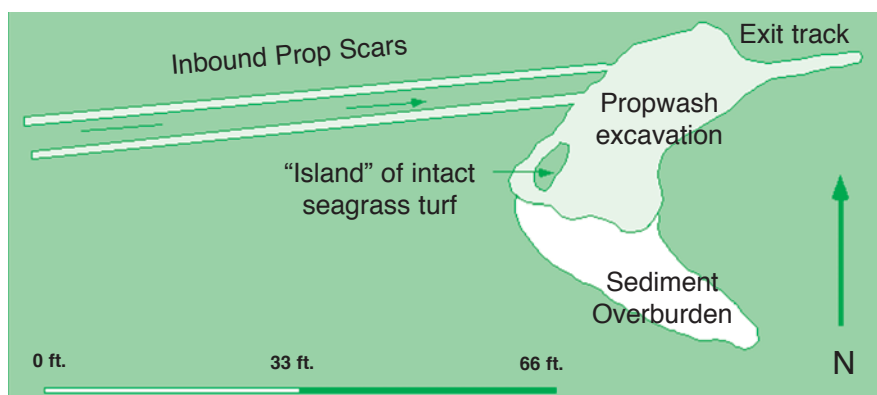
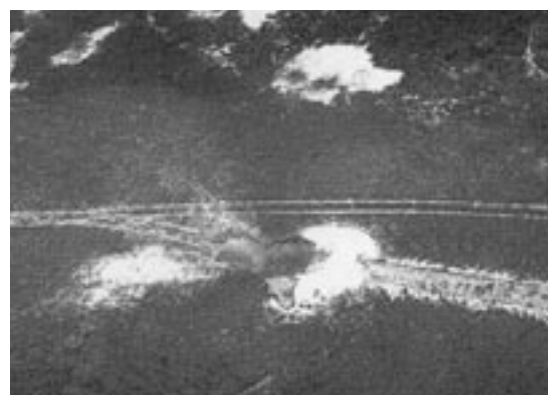
Finally, the propwash excavation by the boat engines caused sediment to become deposited behind the boat on top of unimpacted seagrass (above left). Blow-out scars, entrance and exit tracks, and sediment deposits are all visible in the aerial photograph (above right).
